### SYSTEM IMPROVEMENT AND BENEFIT SUMMARY

**FresherSource**  
ENERGY SOLUTIONS INC.

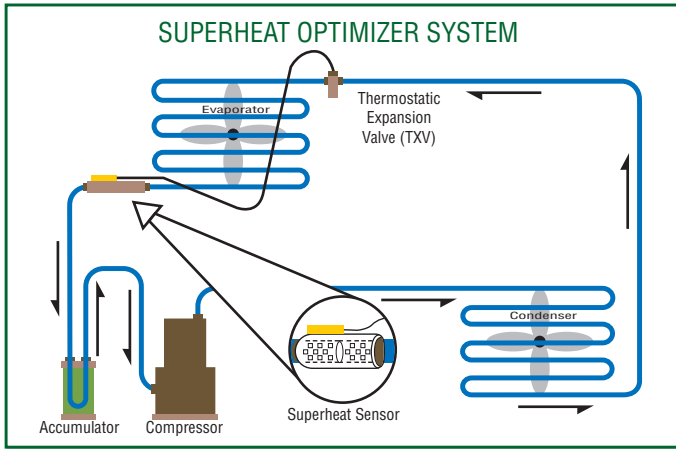
accurate superheat control, thus fully flooding the evaporator. The TXV sensing bulb is secured to the outer sensor tube. To further assist the superheat reading, a groove is formed in the outer tube, of the superheat sensor, to provide additional thermal contact and ensure perfect alignment of the TXV bulb to the suction line.
